# Public Works Report January 2017

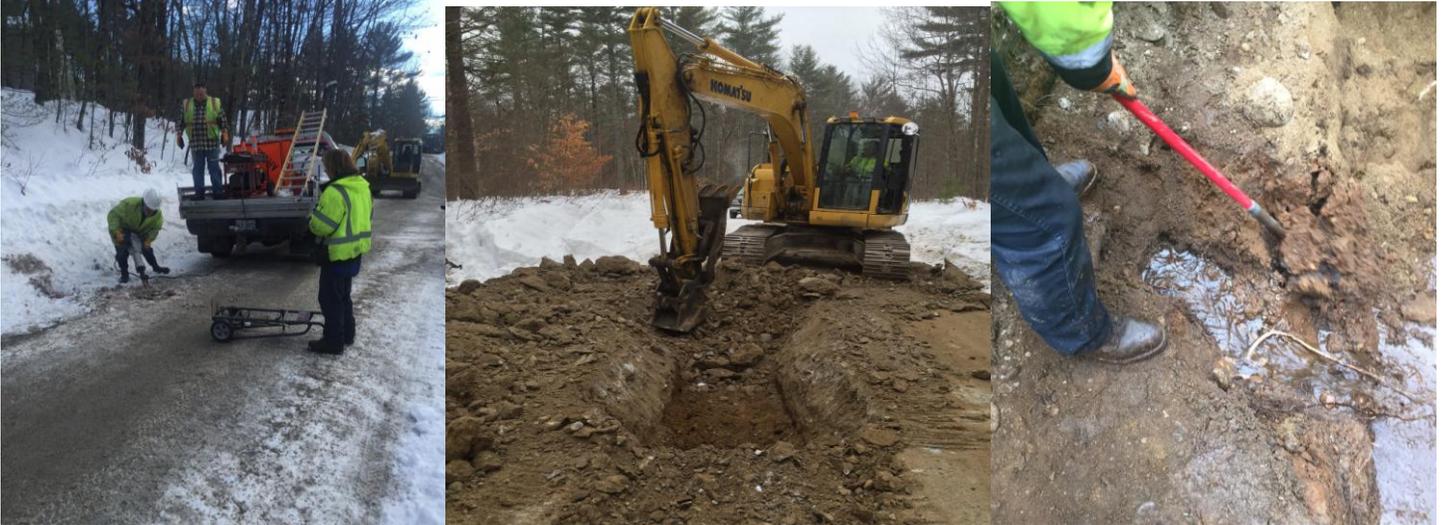
On New Year's Day we had a break on Sunset Drive in Waterboro that was affecting the water pressure in that entire neighborhood. Our crew had been out all night plowing snow and had just barely got home when the call came in. The crew came back right away to fix the problem. We have had many breaks there over the years. That day we got lucky. We located the leak in about an hour then started jack hammering and ripping the frost to access valves and the break. We had it fixed about 8 hours after the first call.
